DEPARTMENT OF TRANSPORTATION

Contract #: 04-0120F4Cty: SF/ALA Rte: 80 PM: 13.2/13.9File #: 1.28**WELDING INSPECTION REPORT****Resident Engineer:** Casey, William**Address:** 333 Burma Road**City:** Oakland, CA 94607**Report No:** WIR-027706**Date Inspected:** 07-Jun-2012**Project Name:** SAS Superstructure**OSM Arrival Time:** 700**Prime Contractor:** American Bridge/Fluor Enterprises, a JV**OSM Departure Time:** 1730**Contractor:** American Bridge/Fluor Enterprises, a JV**Location:** Job Site**CWI Name:** As noted below.**CWI Present:** Yes No**Inspected CWI report:** Yes No N/A**Rod Oven in Use:** Yes No N/A**Electrode to specification:** Yes No N/A**Weld Procedures Followed:** Yes No N/A**Qualified Welders:** Yes No N/A**Verified Joint Fit-up:** Yes No N/A**Approved Drawings:** Yes No N/A**Approved WPS:** Yes No N/A**Delayed / Cancelled:** Yes No N/A**Bridge No:** 34-0006**Component:** Tower Component**Summary of Items Observed:**

Electroslag Weld Excavations

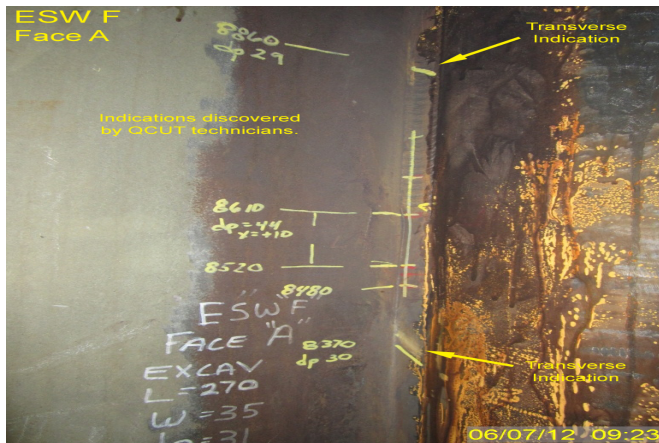
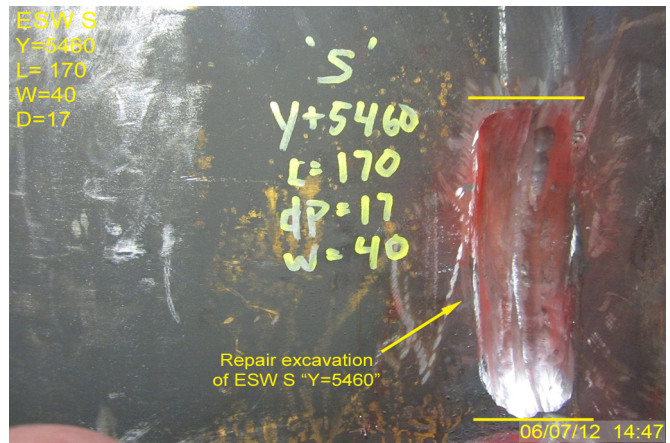
This QA randomly observed ABF/JV welding personnel performing excavation of welds previously Ultrasonic Testing (UT) rejected. Quality Control (QC) Inspector Jesse Cayabyab performed Magnetic Particle (MT) and visual confirmation of excavations. QC observed rejectable indications at the time of testing. Further repair and excavation are required for these welds. Excavations have been recorded and are to be submitted to engineer for further review.

Weld "S" – Y=5460mm, L=170mm, W=40mm, D=17mm

Weld "S" – Y=2700mm, L=180mm, W=40mm, D=20mm

This QA Inspector performed confirmation Magnetic Particle Testing (MT) of weld repair excavations on two locations on tower electroslag welds. This QA observed no rejectable indications at the time of testing.
